Defects Analysis of Tee-Section Welding Using Friction Stir Welding Process of Aluminum

ABSTRACT

Key words: FSW, T-Section, Aluminum 5456, defects analysis, 4mm thickness.

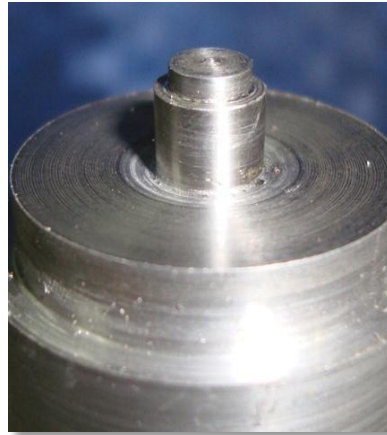
Figure3. Progressive welding tool.

Pin is the second part of the tool. Two types of tool pin had been tried in this work; first type was progressive pin, **Fig.3**. with dimensions of (5mm) diameter for first (4mm) length starting from shoulder face and (3mm) diameter for last (1mm) of length. Progressive did not use because of insufficient ability of stirring; this causes defects in welded joints such as Groove – Like defect. Conical pin tool, **Fig.4** was used with base diameter of (5mm), final diameter of (3mm) and pin length of (5mm).

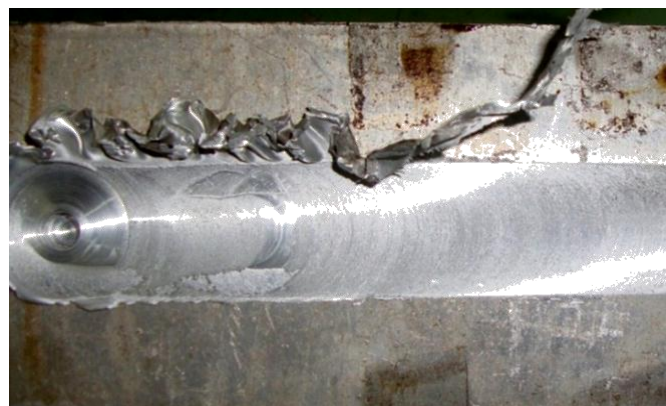
Figure12. Excess flash.

Shoulder voids and even weld misalignment. These defects are visible to the naked eye and are attributed to out of family welding parameters such as excessive travel speed (mm/min.), excessive rotational speed (RPM) , inadequate plunge force loads, and improper joint tracking, **Fig. 12**.

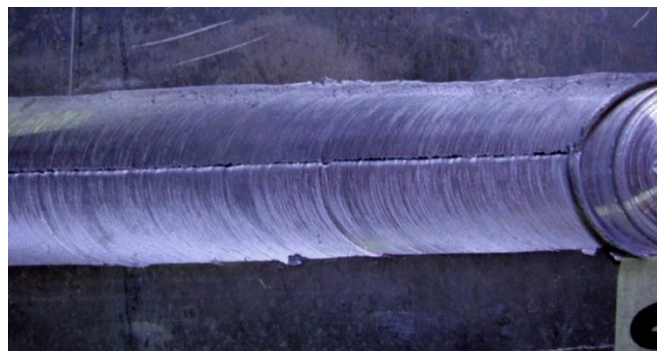
Figure15. Kissing bond defect due to high welding speed (140 mm/min).

Defect that occurs when stirring by the probe tip becomes extremely small. This defect is difficult to detect by standard non-destructive inspection of incomplete welds in which the bonding force was extremely small, **KaijiKyokai , 2010, Fig.15**. According to the weld defect summary mentioned above, defect free joints can be made by selecting adequate conditions, and the most important were (rotational speed, welding speed and plunging depth).
